DRAFT October 2017

# CONSERVATION MASTER PLAN PHASE II

Medway Valley Heritage  
Forest ESA (South)

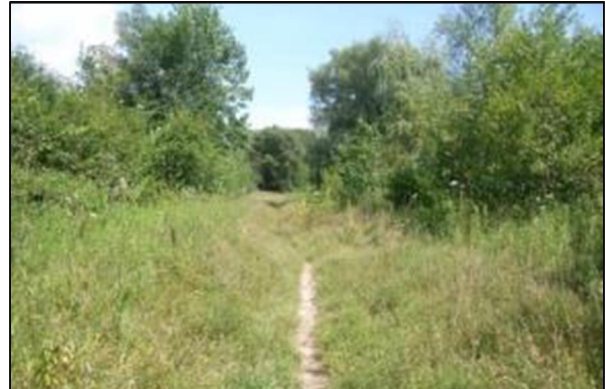
Level 1 trail in a Natural Environment Zone over a Utility Overlay south of Glenridge Crescent

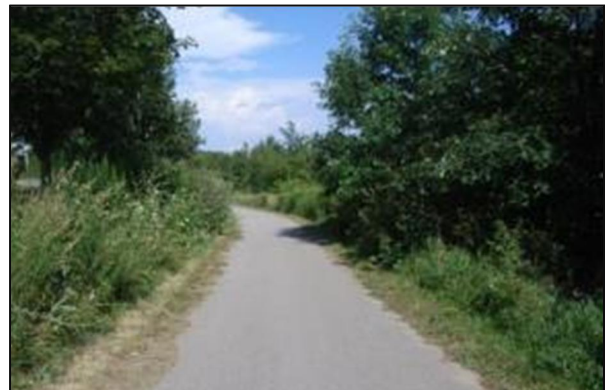
Level 3 trail in a Natural Environment Zone south of Fanshawe Park Road West

In exceptional situations, a Level 3 trail may be permitted within a Natural Environment Zone to upgrade an existing connection between neighbourhoods subject to the 'Process' outlined in Section 2.2 of the Guidelines. These trails provide visitor access and are to be designed and implemented to protect environmental features and to accommodate areas of increased visitor use. Currently, there is one Level 3 trail in the northwest corner of the MVHF ESA (south) that connects Attawandaron Road to Fanshawe Park Road West and the trail system within the MVHF ESA (north).

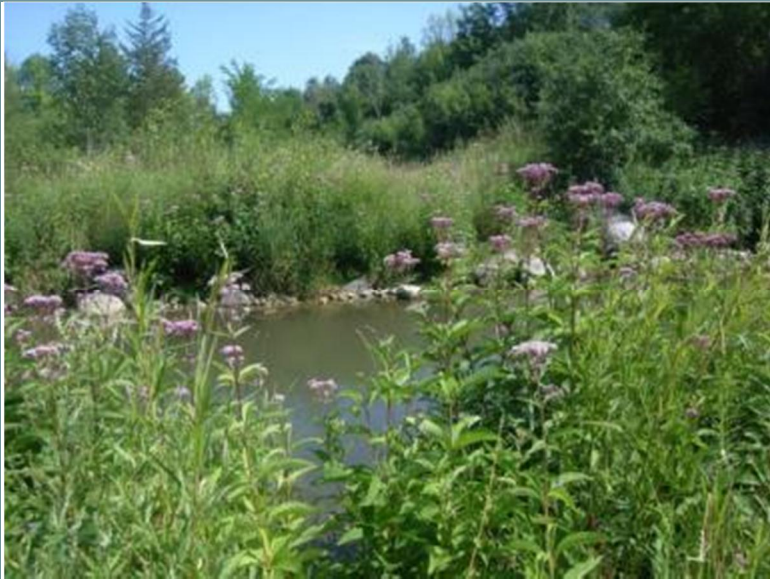
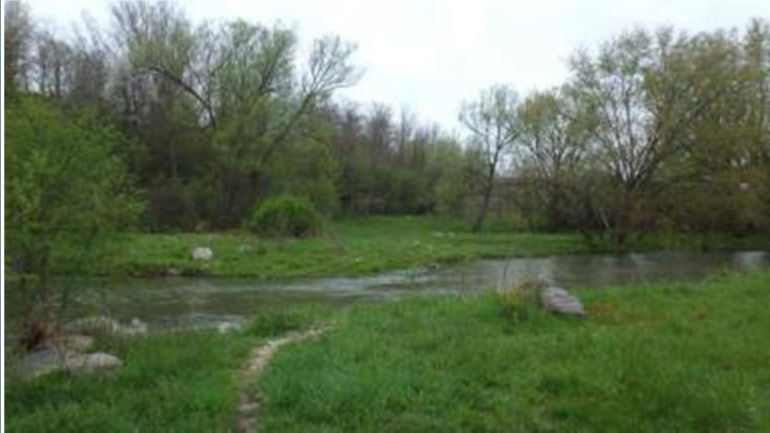
Yes  Currently, managed trails are present up to the wetted edge of Medway Creek, indicating users may be crossing the creek at this location during periods of low-water or when the creek is frozen over.	Yes  A linkage would reduce impacts to the creek banks by formally connecting two segments of managed trails for users to access in a controlled manner.	No  There are no significant ecological features mapped where the potential linkage segment would be located.	Yes  A linkage would directly connect a linear managed trail on the west side of the creek to an existing managed linear and loop system trail on the east side of the creek	Yes  A linkage would overlap the already established 4 m wide Utility Overlay which is comprised primarily of cultural meadow/ forest habitat. Placement within the Utility Overlay would generally not be considered fragmentation of forest habitat as the overlay is to be maintained at 4 m whereas provincial guidelines consider fragmentation to be gaps of 20 metres wide or greater (ORMCP Technical Paper 7, Natural Heritage Reference Manual). An accessible option is possible as the linkage would connect two Level 2 trails (based on the trail concept plan presented in this CMP).	Yes  This linkage would be in compliance with Chart 3 of the Guidelines and recommended to be included in Sustainable Trail Concept Plan.  To improve accessibility in the ESA, a pedestrian bridge over Medway Creek is recommended to be installed that is compliant with AODA standards.  This option is further discussed in Table 11

As presented in the above Table 10, two out of the five linkage options (A and D) suggested by the public comply with the Guidelines. However, compliance with the Guidelines alone does not dictate whether an option is to be included in the proposed sustainable trail concept plan as other considerations have to be made, such as whether a linkage would be able to meet AODA standards/requirements. Of the two linkages that do comply with the Guidelines, the following further considerations were made:

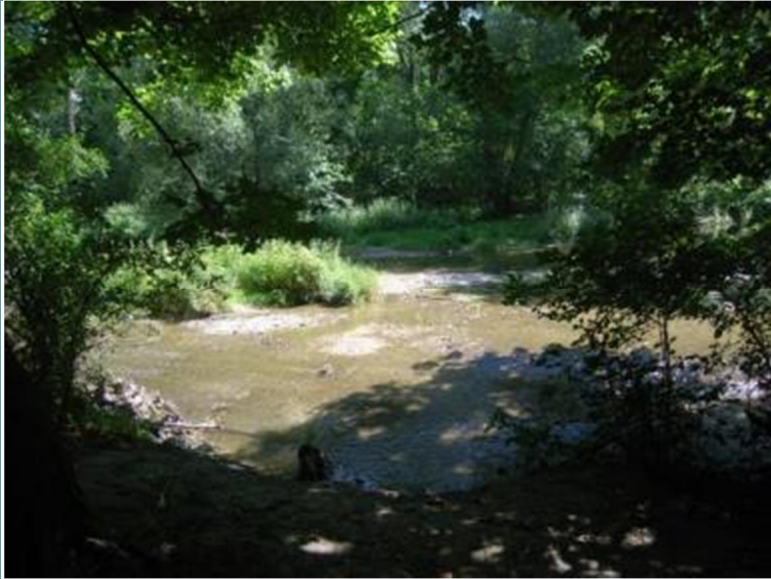
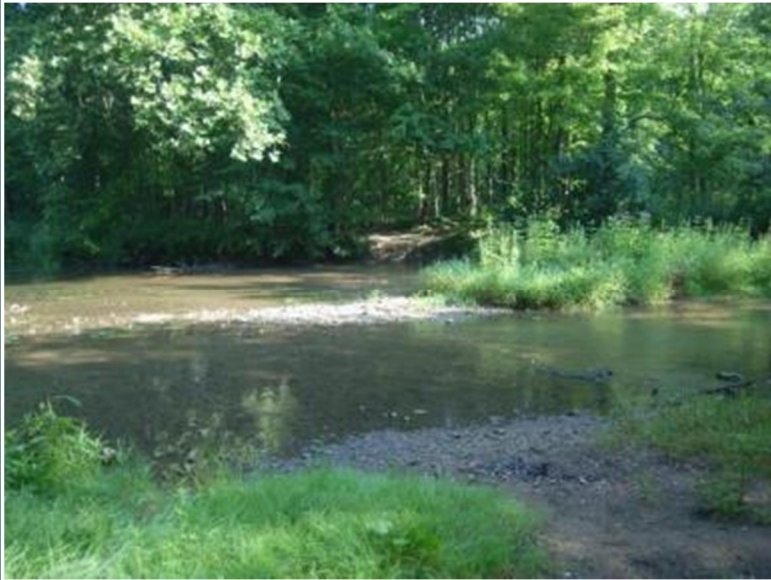
The north side of Medway Creek has evidence of access across the Creek via unmanaged trails extending from a managed trail loop.  Further, trails (both unmanaged and managed) are present up to the wetted edge of Medway Creek, indicating users may be crossing the creek at this location during periods of low-water or when the creek is frozen over.	Well-defined trails prevent trampling; provide an opportunity to promote public awareness of False-Rue Anemone, while also providing a physical barrier that prevents the spread of Goutweed.	Sensitive floodplain Species at Risk and Species of Conservation Concern habitat is mapped on both sides of the creek. These species include False Rue-anemone, American Gromwell and Striped Cream Violet.	To access a linkage in this location, the unmanaged trails extending from a managed trail loop on the north side would need to be formalized and an unmanaged trail loop formalized on the south side of the creek.	A linkage would overlap the already established 4 m wide Utility Overlay which is comprised primarily of cultural meadow/ forest habitat. Placement within the Utility Overlay would generally not be considered fragmentation of forest habitat as the overlay is to be maintained at 4 m whereas provincial guidelines consider fragmentation to be gaps of 20 metres wide or greater (ORMCP Technical Paper 7, Natural Heritage Reference Manual).  This linkage would be limited with respect to accessibility as it would connect two Level 1 trails (based on the trail concept plan presented in this CMP).	This linkage would not be in compliance with Chart 3 of the Guidelines due to the presence of significant ecological features that would require relocation.  Not recommended to be included in Sustainable Trail Concept Plan.

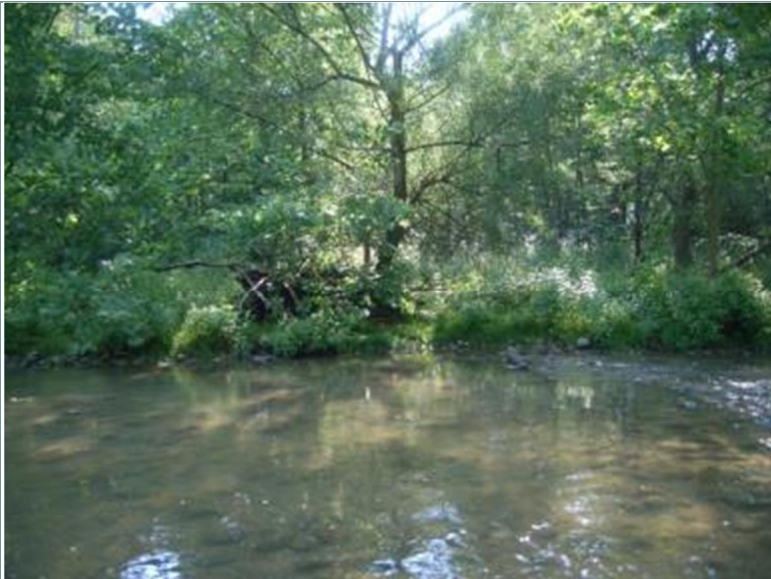
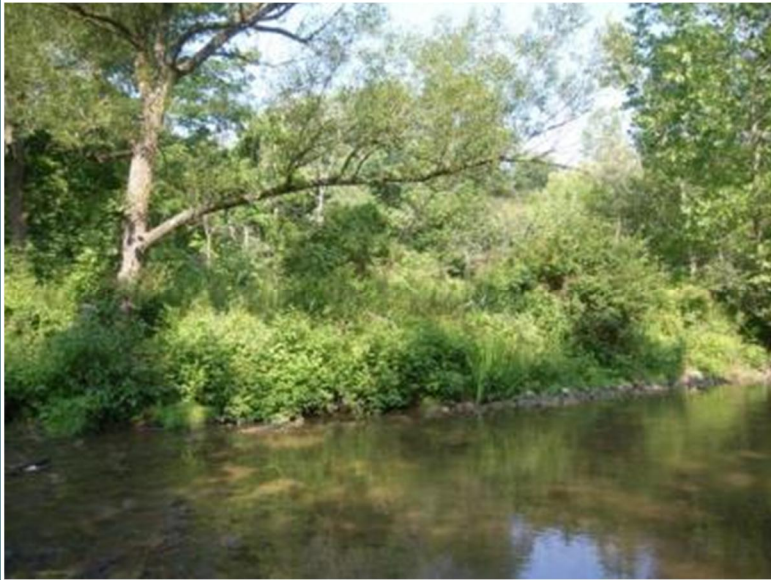
<p>Looking east from south bank of creek (August 2017)</p> <p>Looking west from south bank of creek (August 2017)</p>	There are few indications that this area is subject to user access across the creek. There is some evidence that users accessing the managed trail along the eastern bank of the creek may move to the water's edge.		Sensitive floodplain Species at Risk and Species of Conservation Concern habitat is mapped on both sides of the creek. These species include False Rue-anemone and American Gromwell.	A linkage would connect a managed trail to the east and require new trails on the west side and/or formalizing unmanaged trails.	A linkage would overlap the already established 4 m wide Utility Overlay which is comprised primarily of cultural meadow/ forest habitat. Placement within the Utility Overlay would generally not be considered fragmentation of forest habitat as the overlay is to be maintained at 4 m whereas provincial guidelines consider fragmentation to be gaps of 20 metres wide or greater (ORMCP Technical Paper 7, Natural Heritage Reference Manual). This linkage would be limited with respect to accessibility as it would connect two Level 1 trails (based on the trail concept plan presented in this CMP).	This linkage would not be in compliance with Chart 3 of the Guidelines due to presence of significant ecological features that would require relocation.

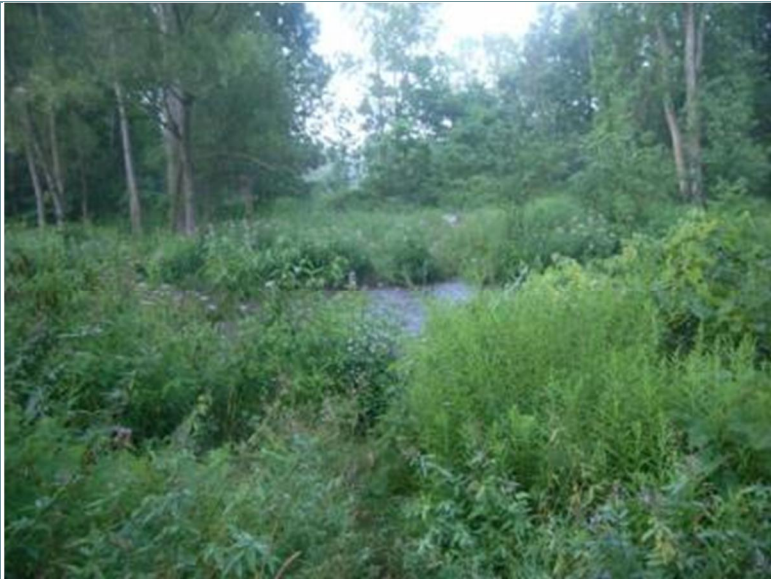
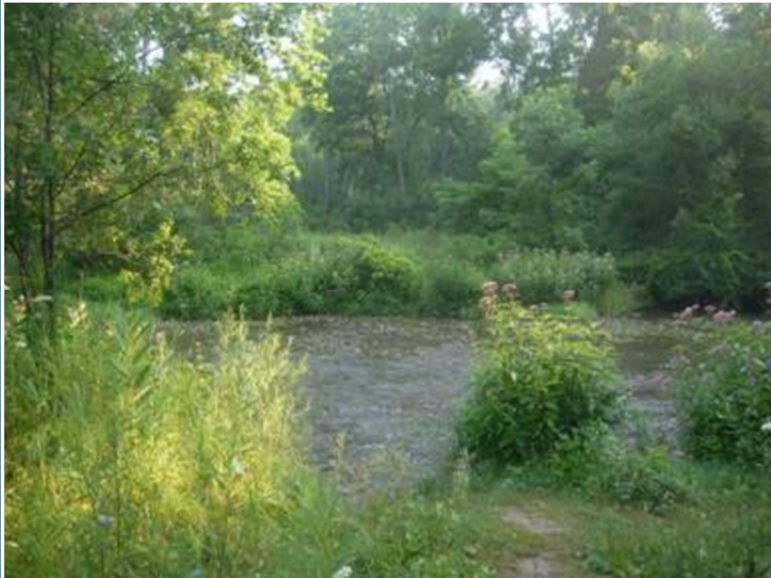
There is evidence that users are congregating at the creek banks and possibly crossing during periods of low-water or iced over conditions.	Installation of a linkage would help direct people to the managed trail loops instead of using nearby unmanaged trails. A linkage would reduce impacts to the creek banks by formally connecting two segments of managed trails for users to access in a controlled manner	There are no significant features mapped where the linkage would be located.	A linkage would connect two existing, managed trail loops.	A linkage would overlap the already established 4 m wide Utility Overlay which is comprised primarily of cultural meadow/ forest habitat. Placement within the Utility Overlay would generally not be considered fragmentation of forest habitat as the overlay is to be maintained at 4 m whereas provincial guidelines consider fragmentation to be gaps of 20 metres wide or greater (ORMCP Technical Paper 7, Natural Heritage Reference Manual). This linkage would be limited with respect to accessibility as it would connect to a Level 1 trail on the north side (based on the trail concept plan presented in this CMP).	This linkage would be in compliance with Chart 3 of the Guidelines. Not recommended to be included in Sustainable Trail Concept Plan.

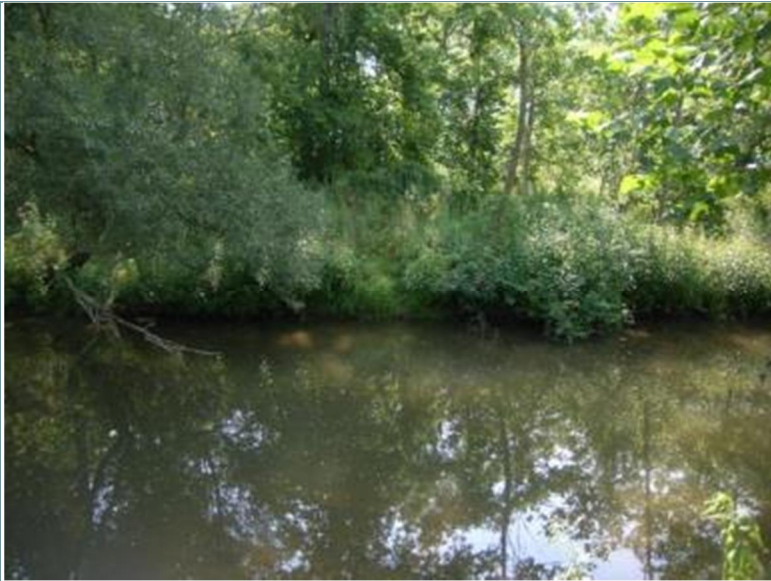
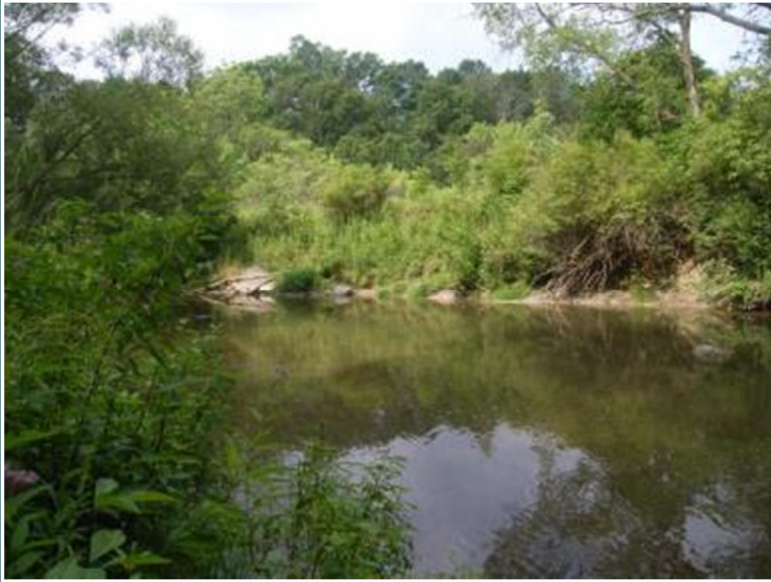
No	N/A	Yes  Sensitive floodplain Species of Conservation Concern habitat is mapped on the east side of the creek. This includes American Gromwell.	Yes  A linkage would connect two managed trail loops.	Yes  A linkage would overlap the already established 4 m wide Utility Overlay which is comprised primarily of cultural meadow/ forest habitat. Placement within the Utility Overlay would generally not be considered fragmentation of forest habitat as the overlay is to be maintained at 4 m whereas provincial guidelines consider fragmentation to be gaps of 20 metres wide or greater (ORMCP Technical Paper 7, Natural Heritage Reference Manual). An accessible option is possible as the linkage would connect two Level 2 trails (based on the trail concept plan presented in this CMP).	No  This linkage would not be in compliance with Chart 3 of the Guidelines due to presence of significant ecological features that would require relocation.  Not recommended to be included in Sustainable Trail Concept Plan.

Evidence of crossing Medway Creek in this location was not observed. Due to the formation of an unmanaged trail along the eastern bank of the creek, it is assumed that the depth of the water may deter informal crossings.

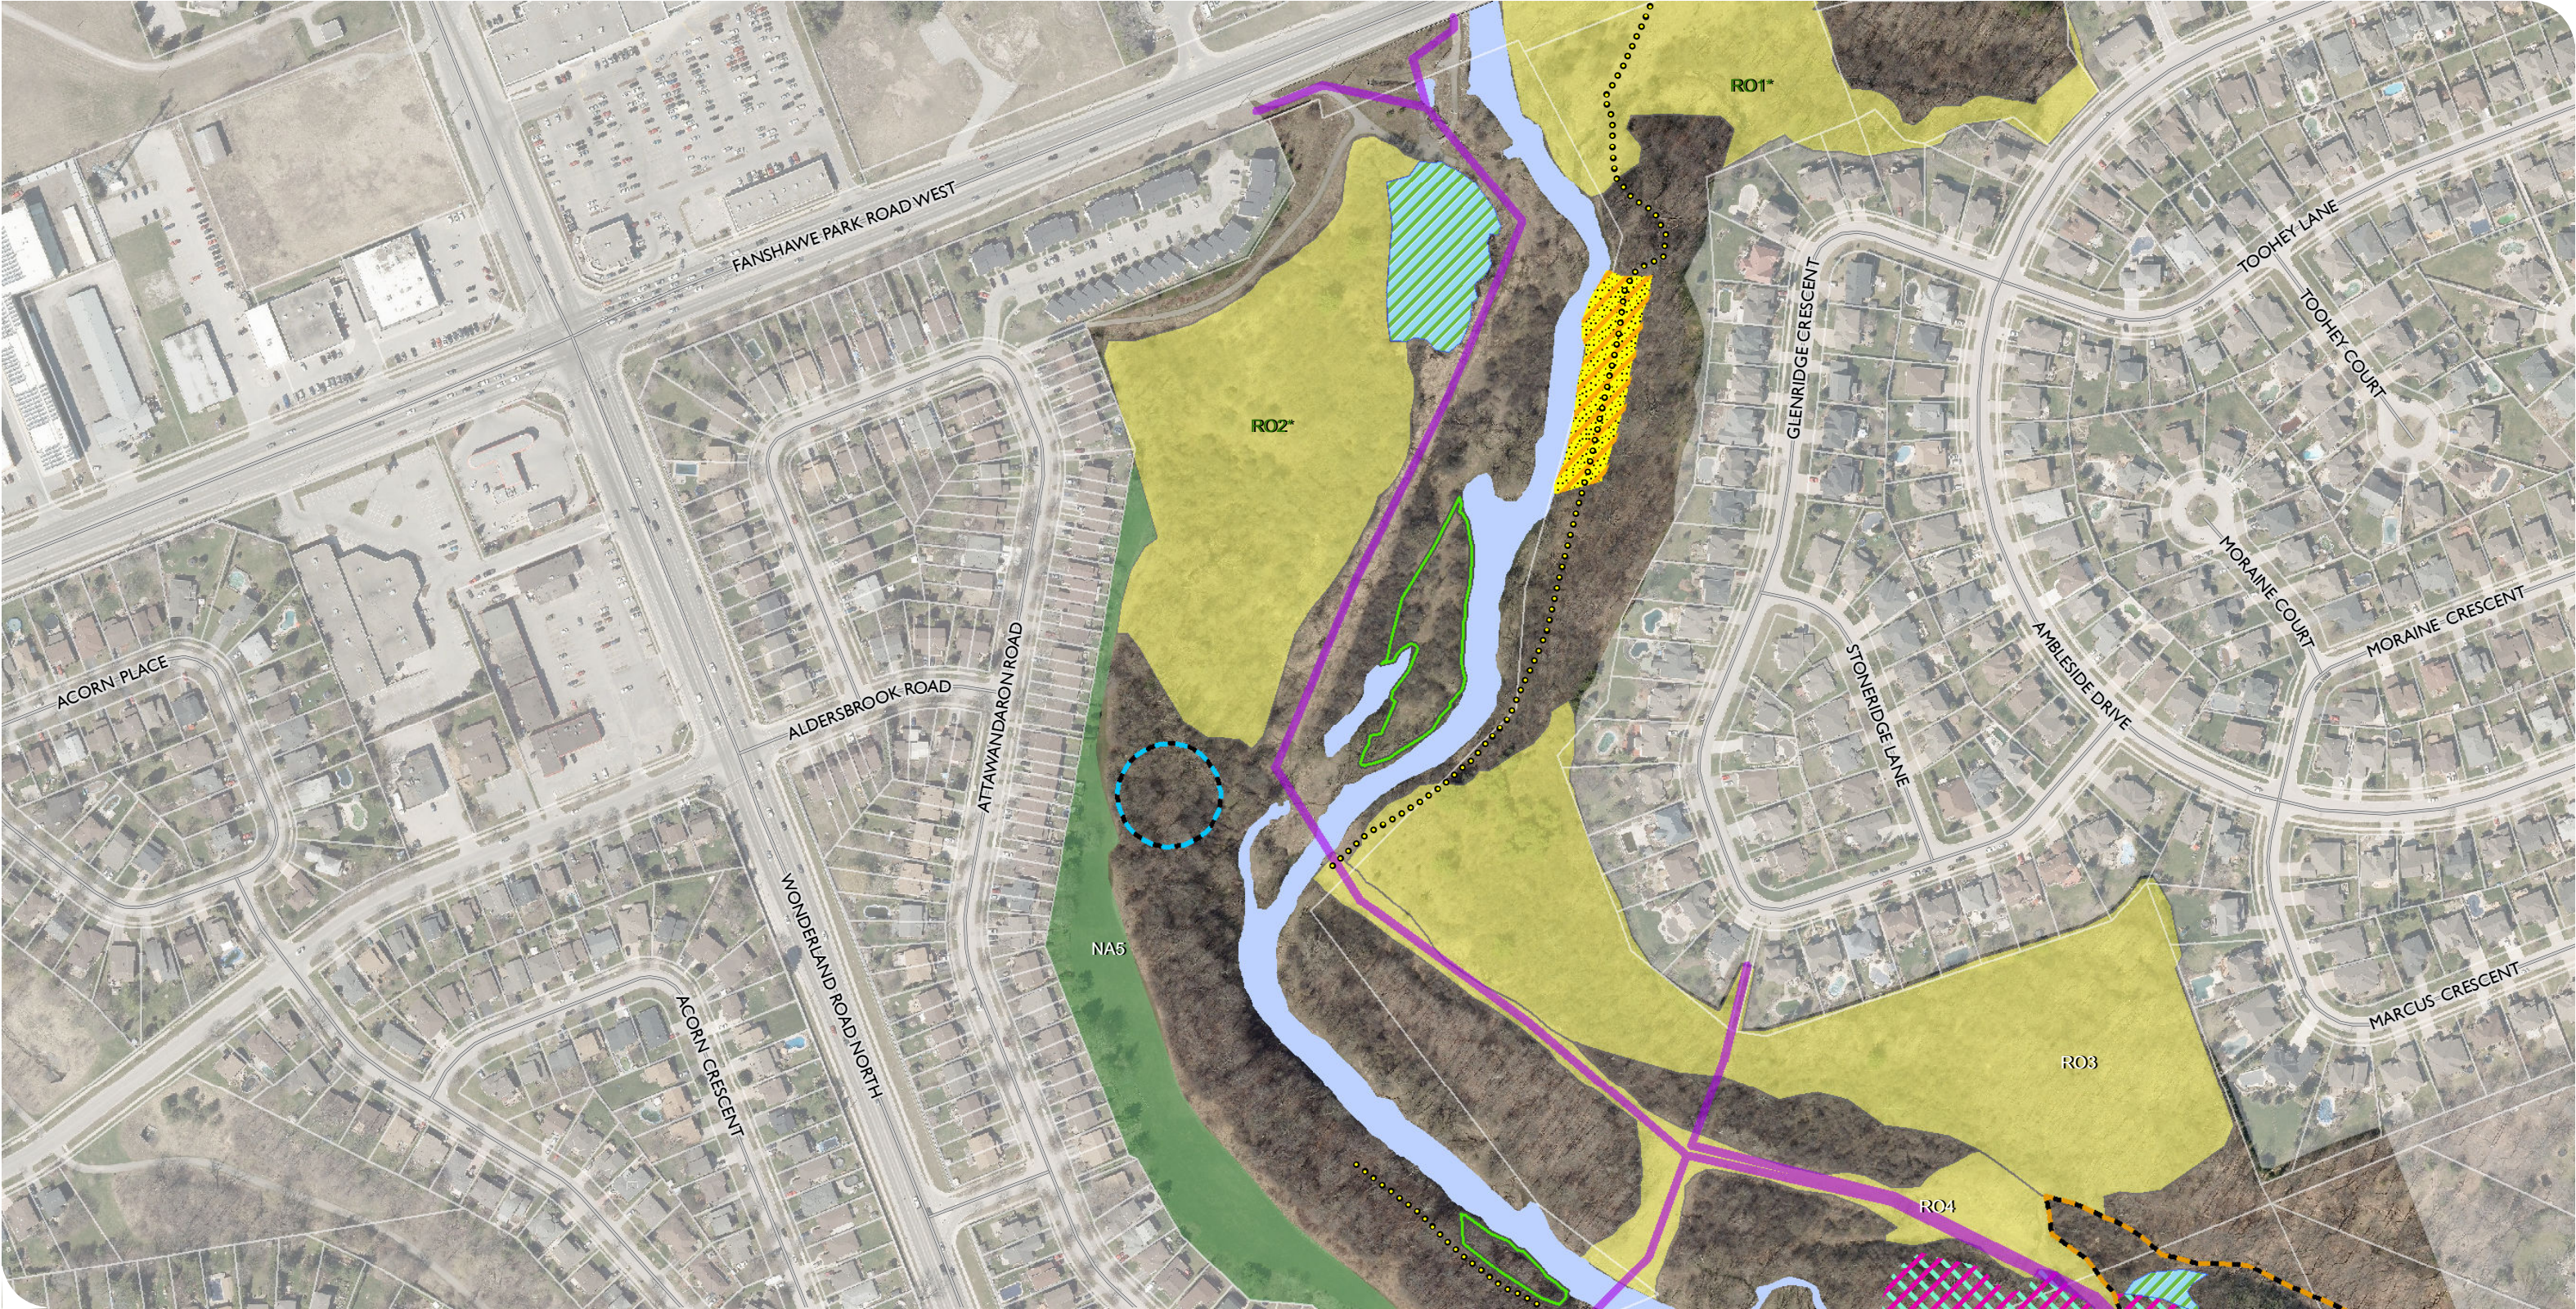
**FIGURE 2a**  
ENVIRONMENTAL MANAGEMENT STRATEGY  
(RESTORATION & NATURALIZATION)

<sup>1</sup>Restoration Overlay labels for RO 1, 2, 5, 10, 11, 13, 14, 15 are highlighted in green and have a \* to indicate restoration works are either already complete and/or currently in progress and under a monitoring program.  
<sup>2</sup>RO16 identifies informal and closed existing trails documented during Phase I that are to be closed (or closure enforced) and restored

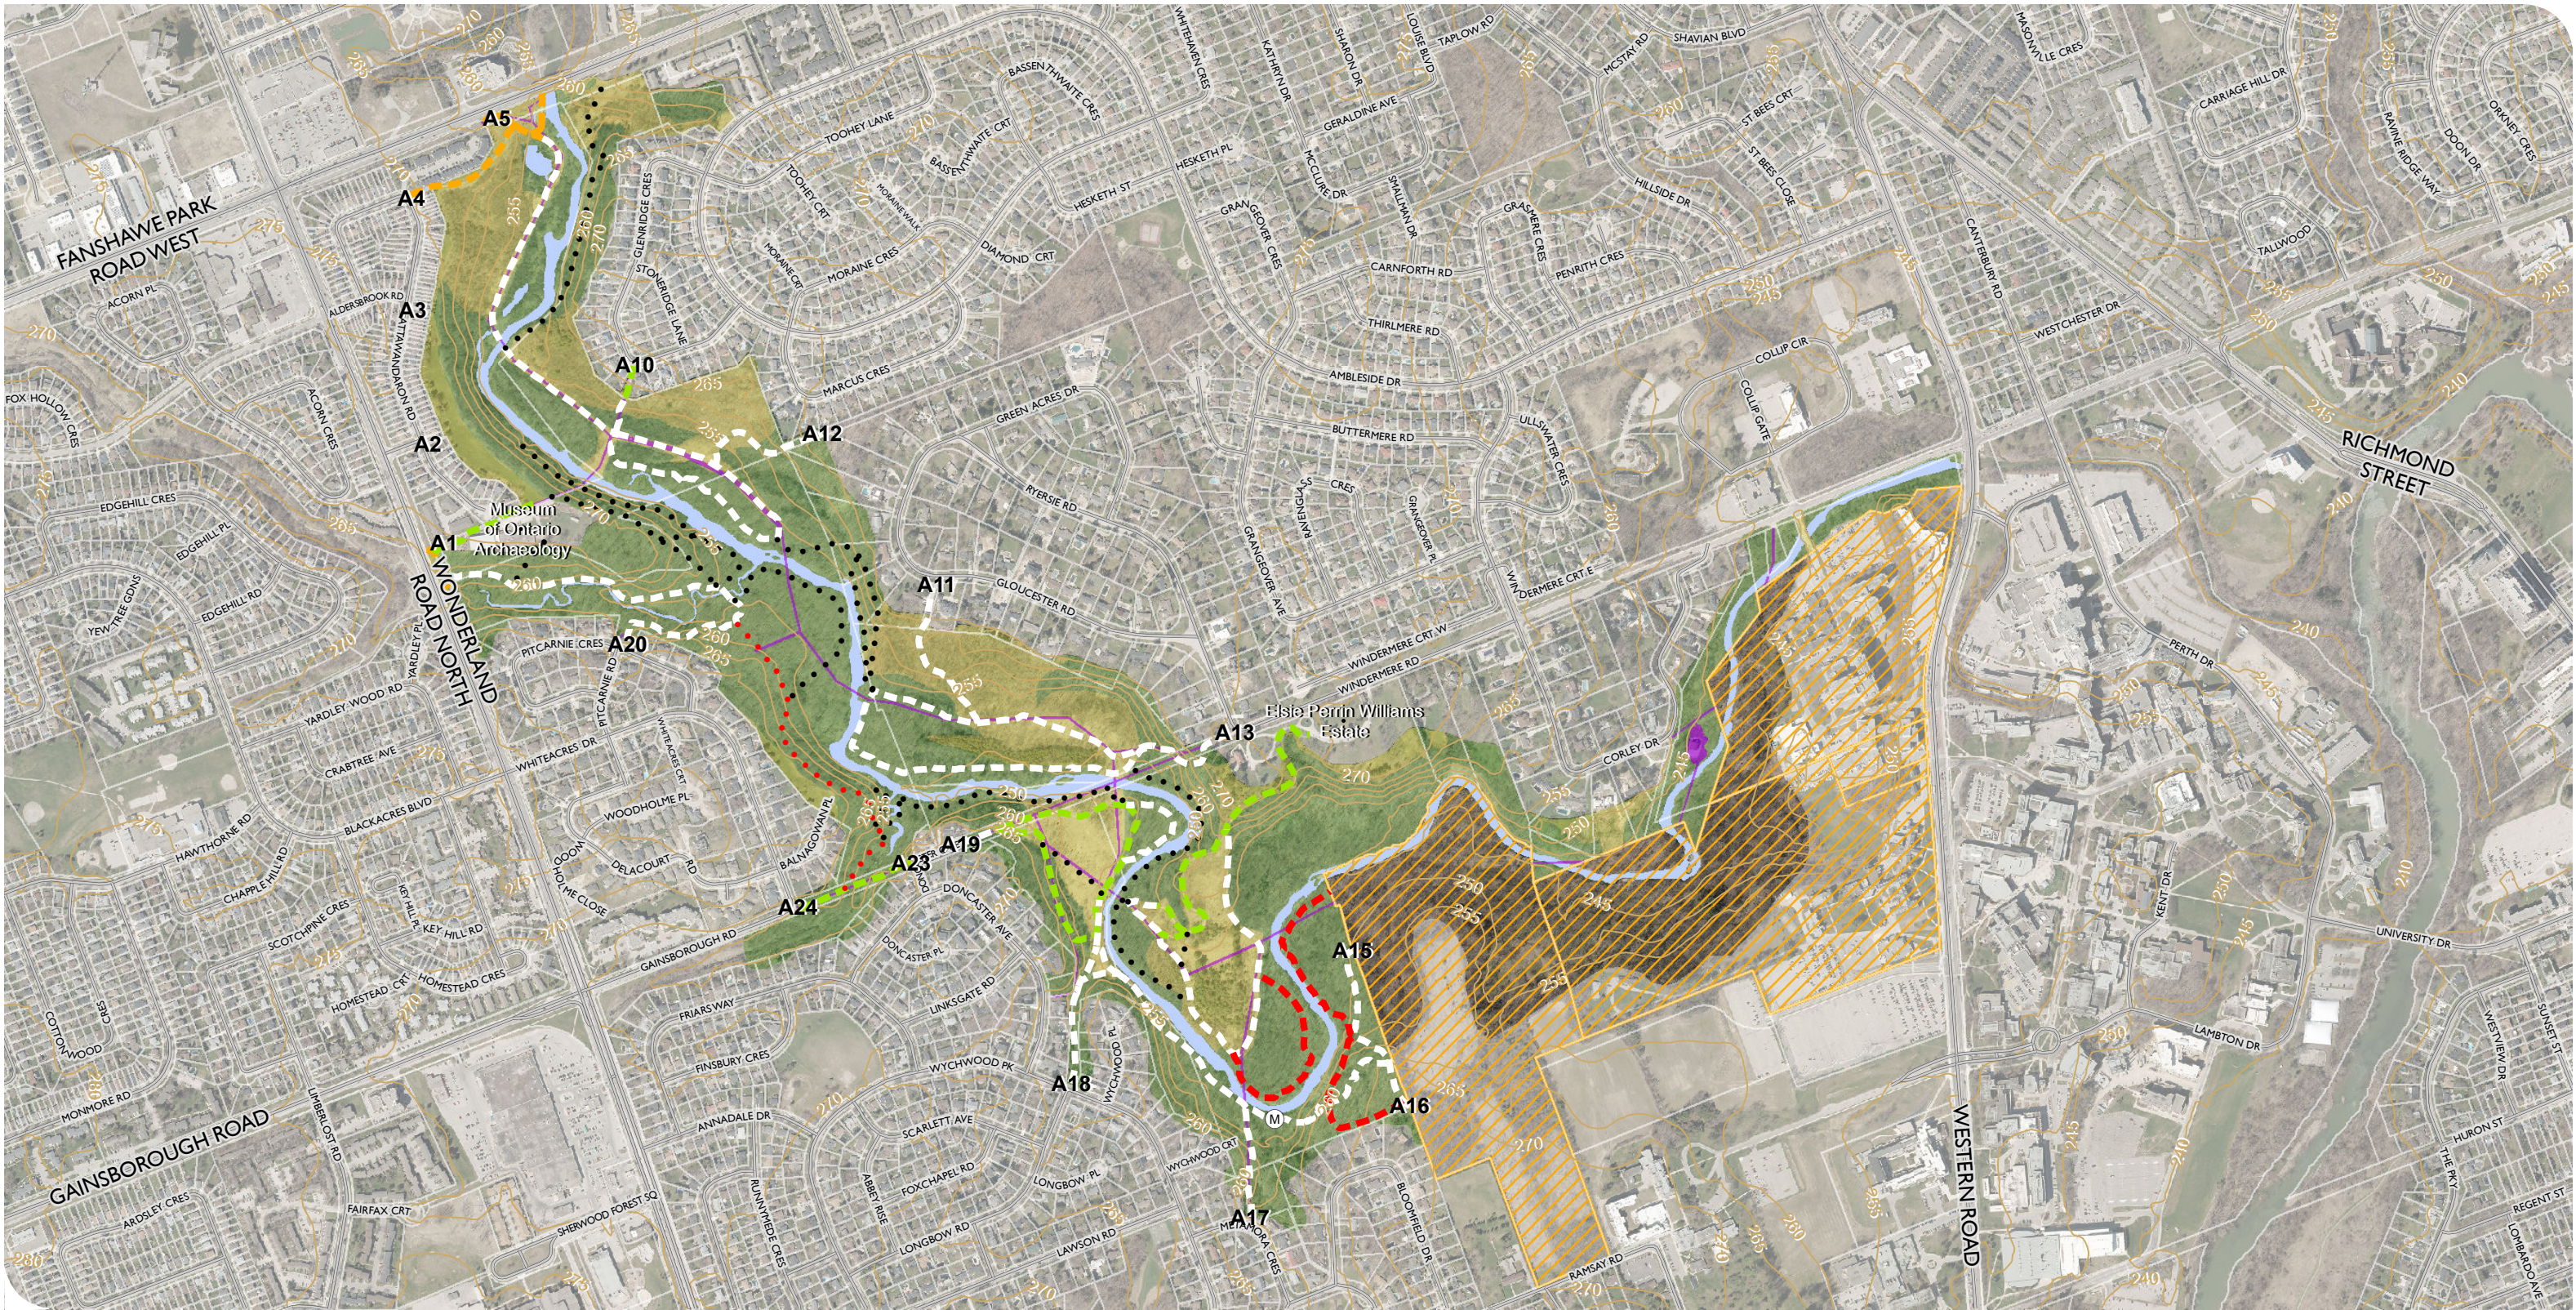
**FIGURE 3**  
ENVIRONMENTAL MANAGEMENT STRATEGY:  
EXISTING TRAIL SYSTEM

<sup>1</sup>INFORMAL AND CLOSED EXISTING TRAILS DOCUMENTED DURING PHASE I ARE TO BE CLOSED AND RESTORED (SEE R016 ON FIGURE 2).  
<sup>2</sup>TEMPORARILY CLOSED TRAIL TO BE REOPENED/REALIGNED.  
SECTIONS NOT REALIGNED WILL BE CLOSED AND RESTORED

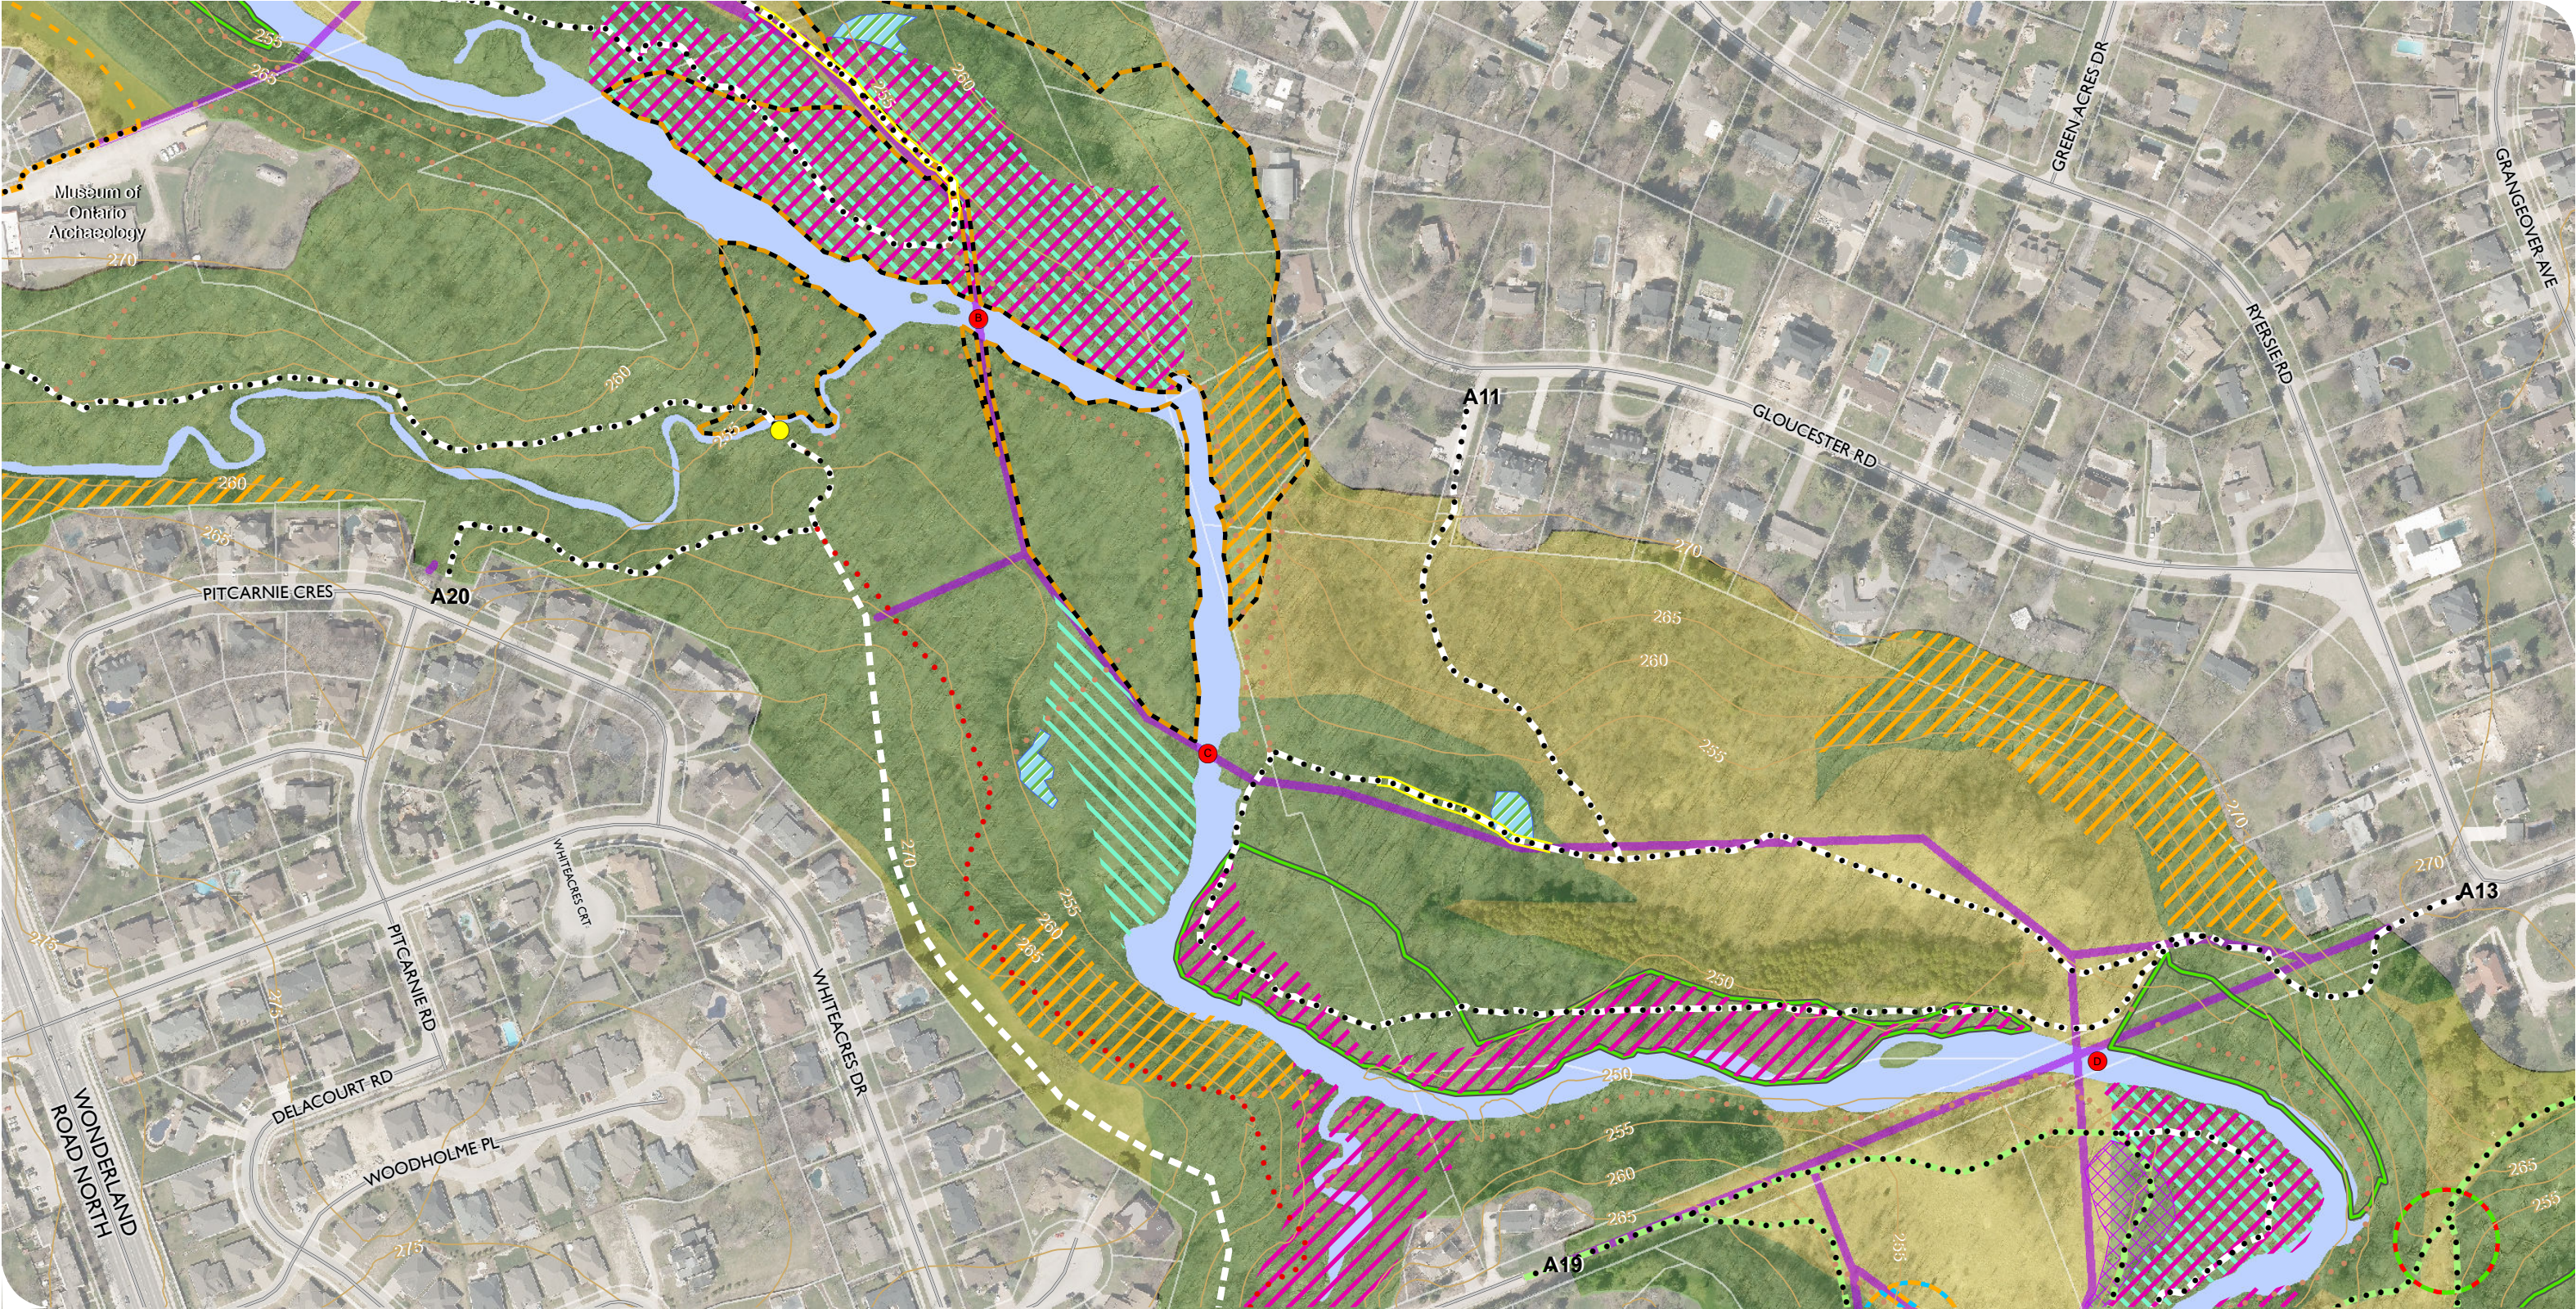
**FIGURE 4b**  
ENVIRONMENTAL MANAGEMENT STRATEGY:  
PROPOSED SUSTAINABLE  
TRAIL CONCEPT PLAN

- A# Access Point (not recommended for implementation)
- Proposed Trail Linkage
  - Proposed Trail Linkage (Snake Creek)
  - Contour (5 metre Elevation)

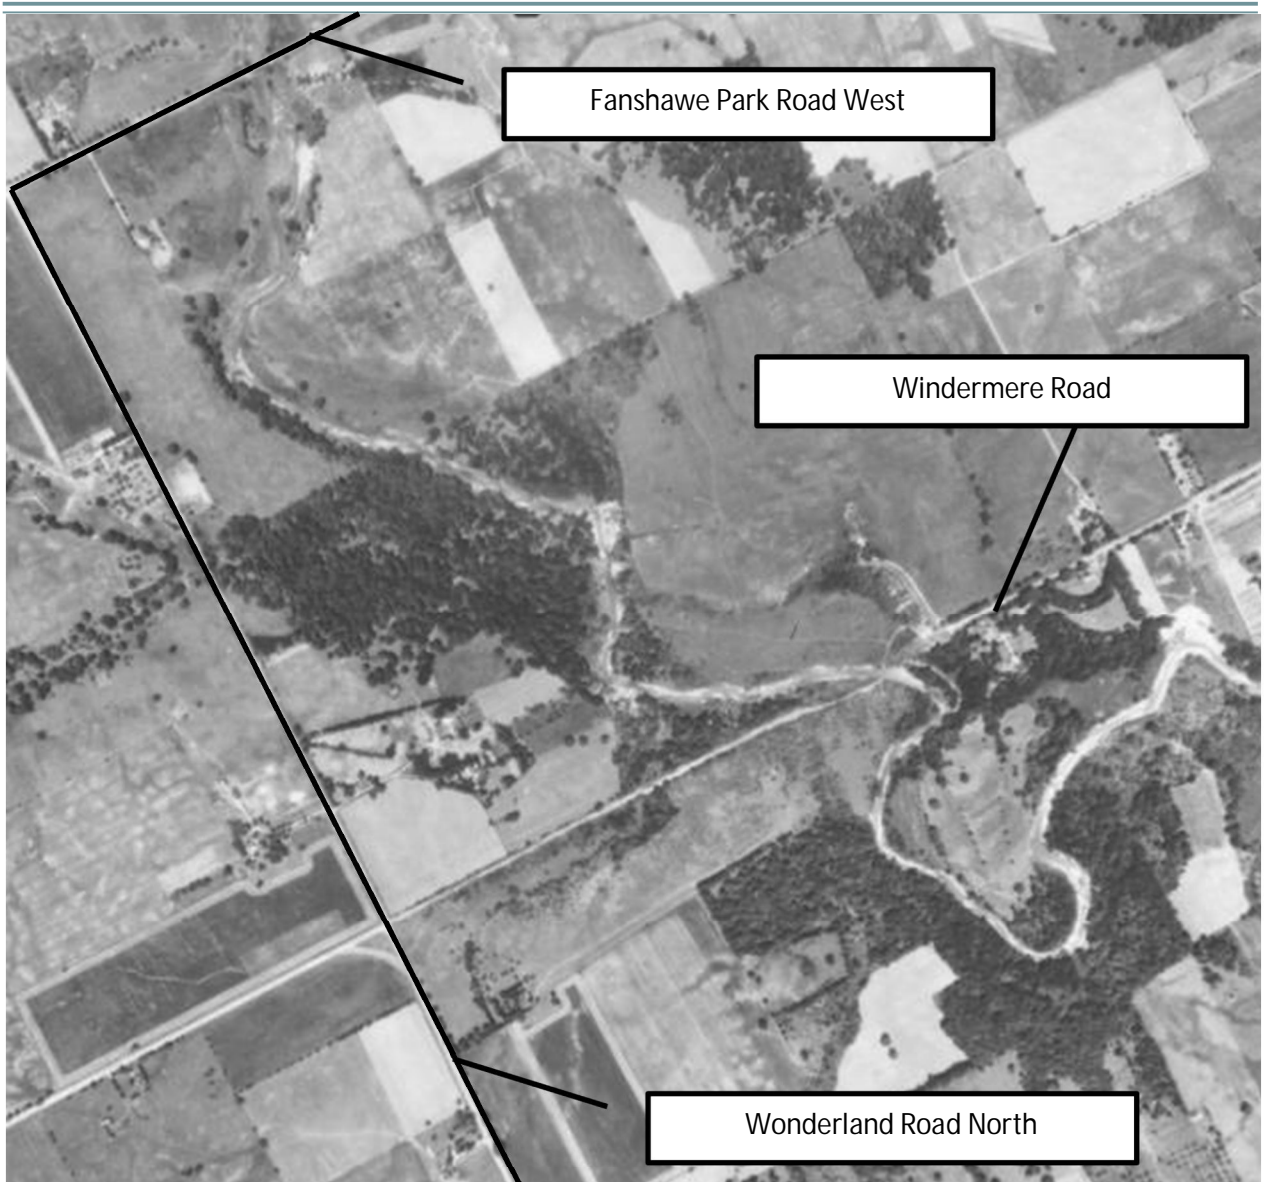
1942

Aerial Photographs of the MVHF ESA (south)<sup>1</sup>
